STEVENS POND OUTLET DAM

MA 00232

PHASE I INSPECTION REPORT  
NATIONAL DAM INSPECTION PROGRAM

AUGUST 1978

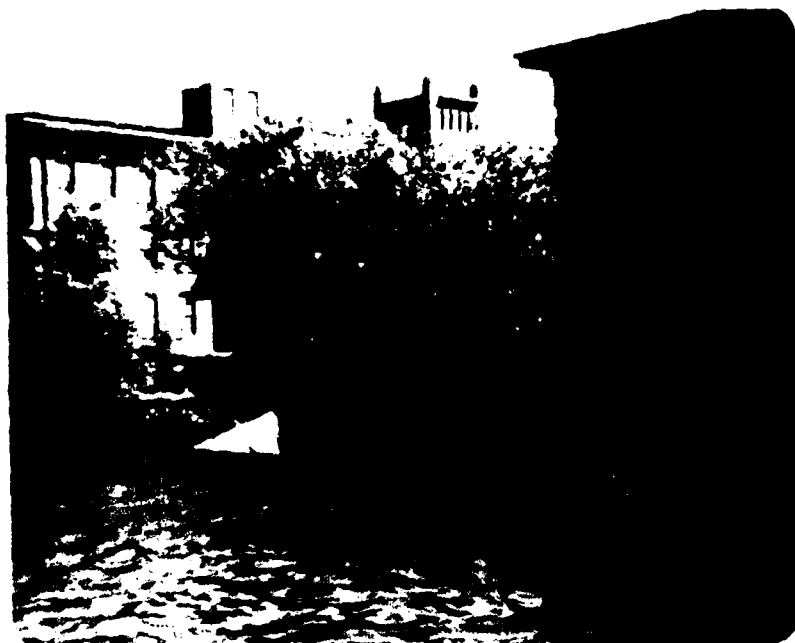
b. Dam. The over 100 year old dam is constructed on bed rock and is apparently in good condition. The granite block structure, although appropriately weathered, appears to be structurally sound. No significant horizontal or vertical misalignments were noticeable. Overflow prevents determining whether or not there is leakage through the joints. There is some growth at the left abutment and where the spillway joins the gate house on the right abutment.

Upstream View of Spillway  
from Right Bank

b. Operating and Maintenance Procedures. Presently required maintenance includes the repair of any loose or spalled concrete at the abutments and the general dressing-up of the facility. The owner of the dam should develop and implement procedures which would include:

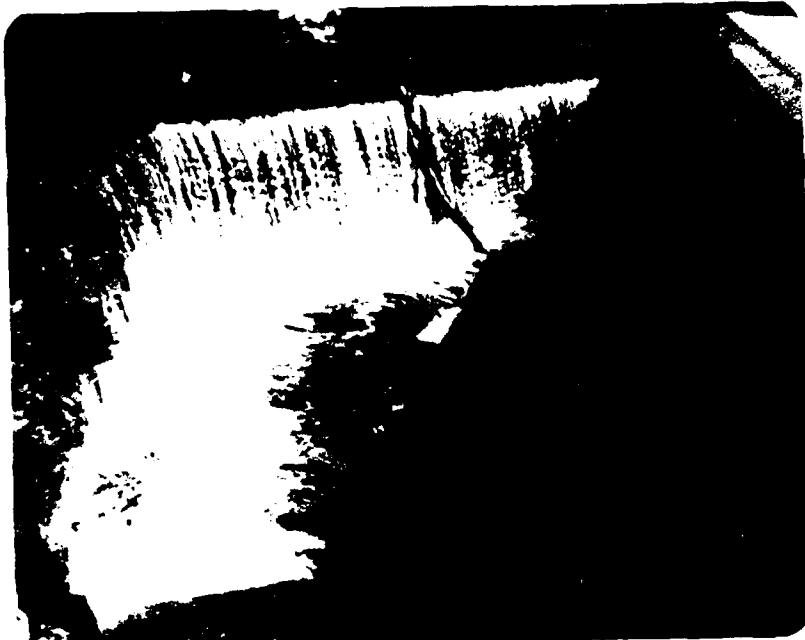
3

Downstream View of Spillway  
from Right Bank

(2) The channel between the dam and Broadway should be cleared, and kept clear, of growth and debris.

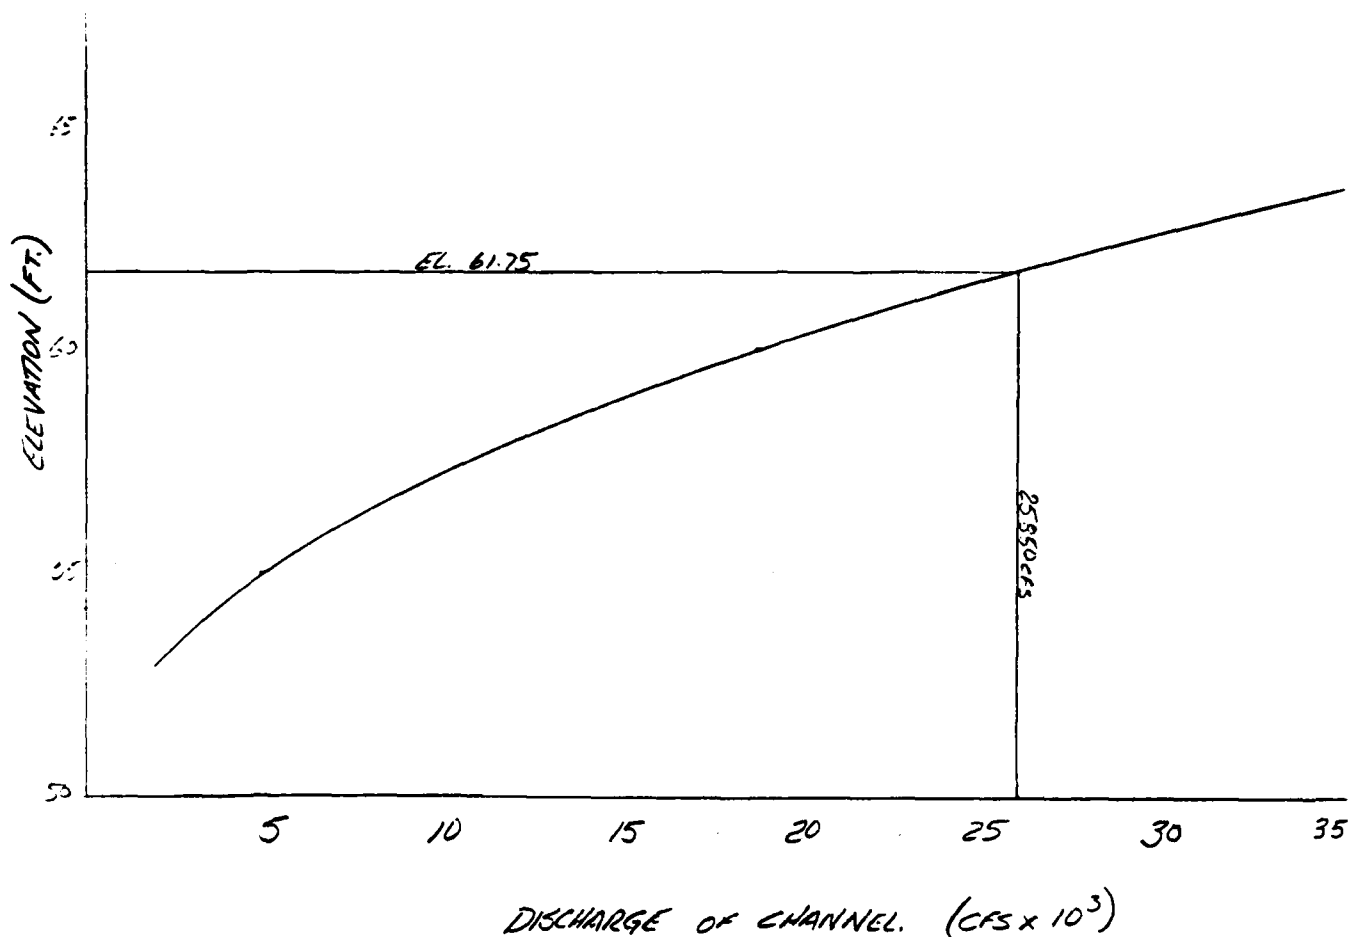
REACH I Q = 25850 CFS. EL. 61.75

RESULTS IN FIRST REACH DISASTROUS - EXTREME FLOODING  
THROUGH FACTORY AREA - OVER BROADWAY INTO RESIDENTIAL  
AREA. LARGE HAZARD TO LIFE
